# Washington's Seismic Vulnerability: Implications for Transportation Planning and Projects

Timothy J. Walsh

Washington Department of Natural  
Resources

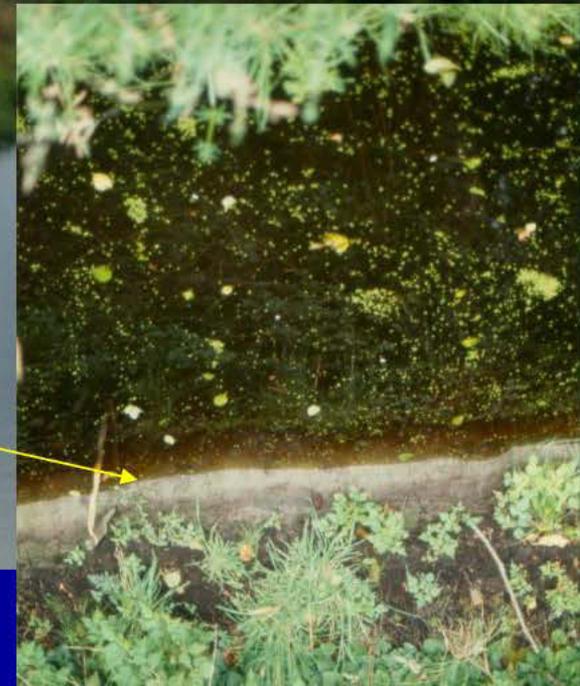
**House built at the top of the  
Waterman Point fault scarp**

Tsunami sand sheet at Cultus Bay on Whidbey Island

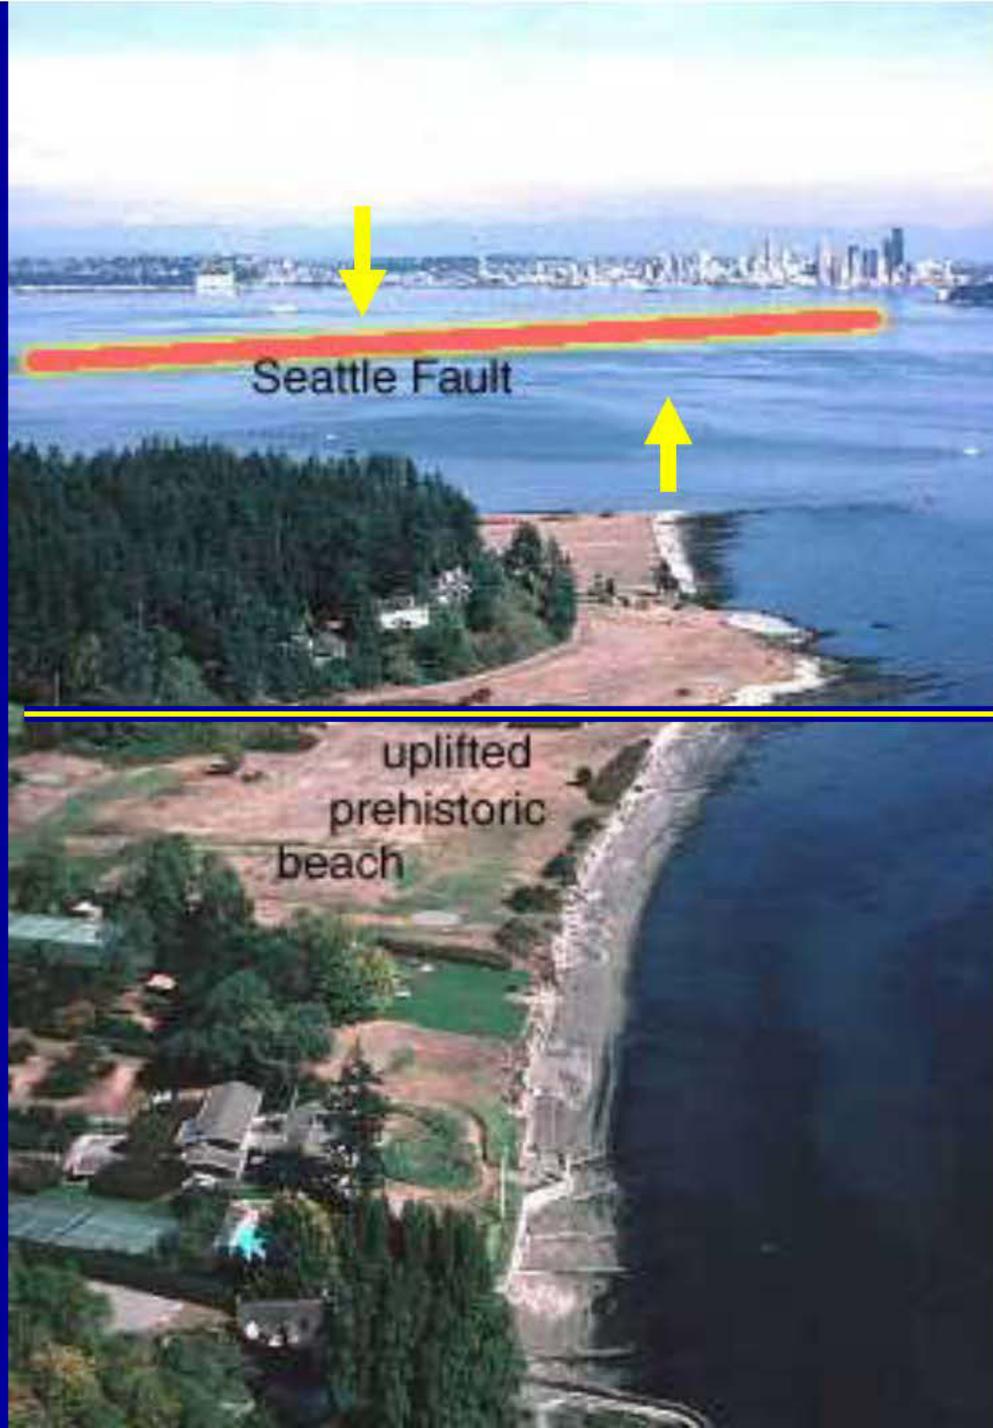
Using estimated land level changes at Restoration Point, Alki Point, West Point, and Winslow Marsh, we constructed a Seattle fault model to use in the tsunami simulation

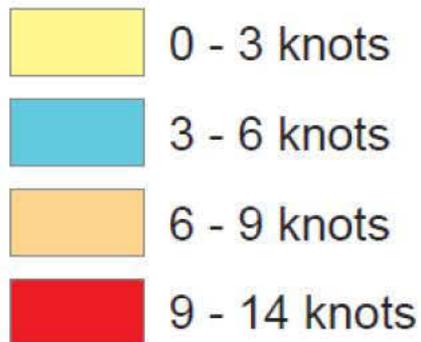
### Maximum Current

This map shows the currents generated by this tsunami, which reaches 14 knots around the Port of Everett

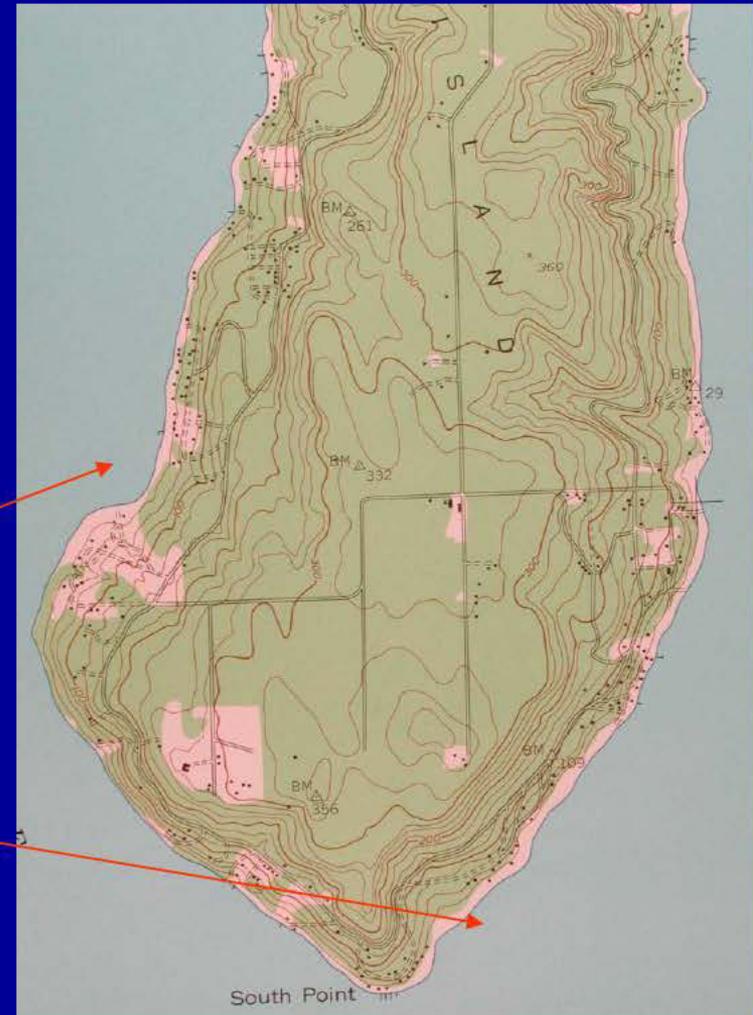
# Seattle Fault Earthquake-Induced Landslides

Shaded-relief lidar image of Mercer Island highlighting possible inactive (?) landslide Areas (note: areas not field checked)

Large landslide off SE side of Mercer Island with associated  $\pm 1,000$  year old submarine landslide

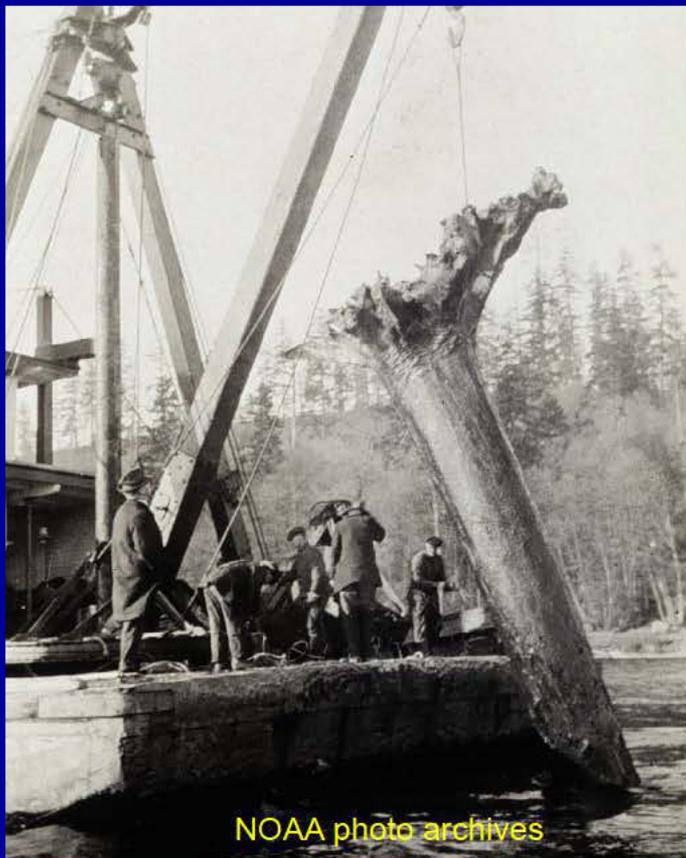
# Old growth forest in Lake Washington

- Earthquake-induced landslides in Lake Washington drowned old Growth Forests about 1,000 years ago

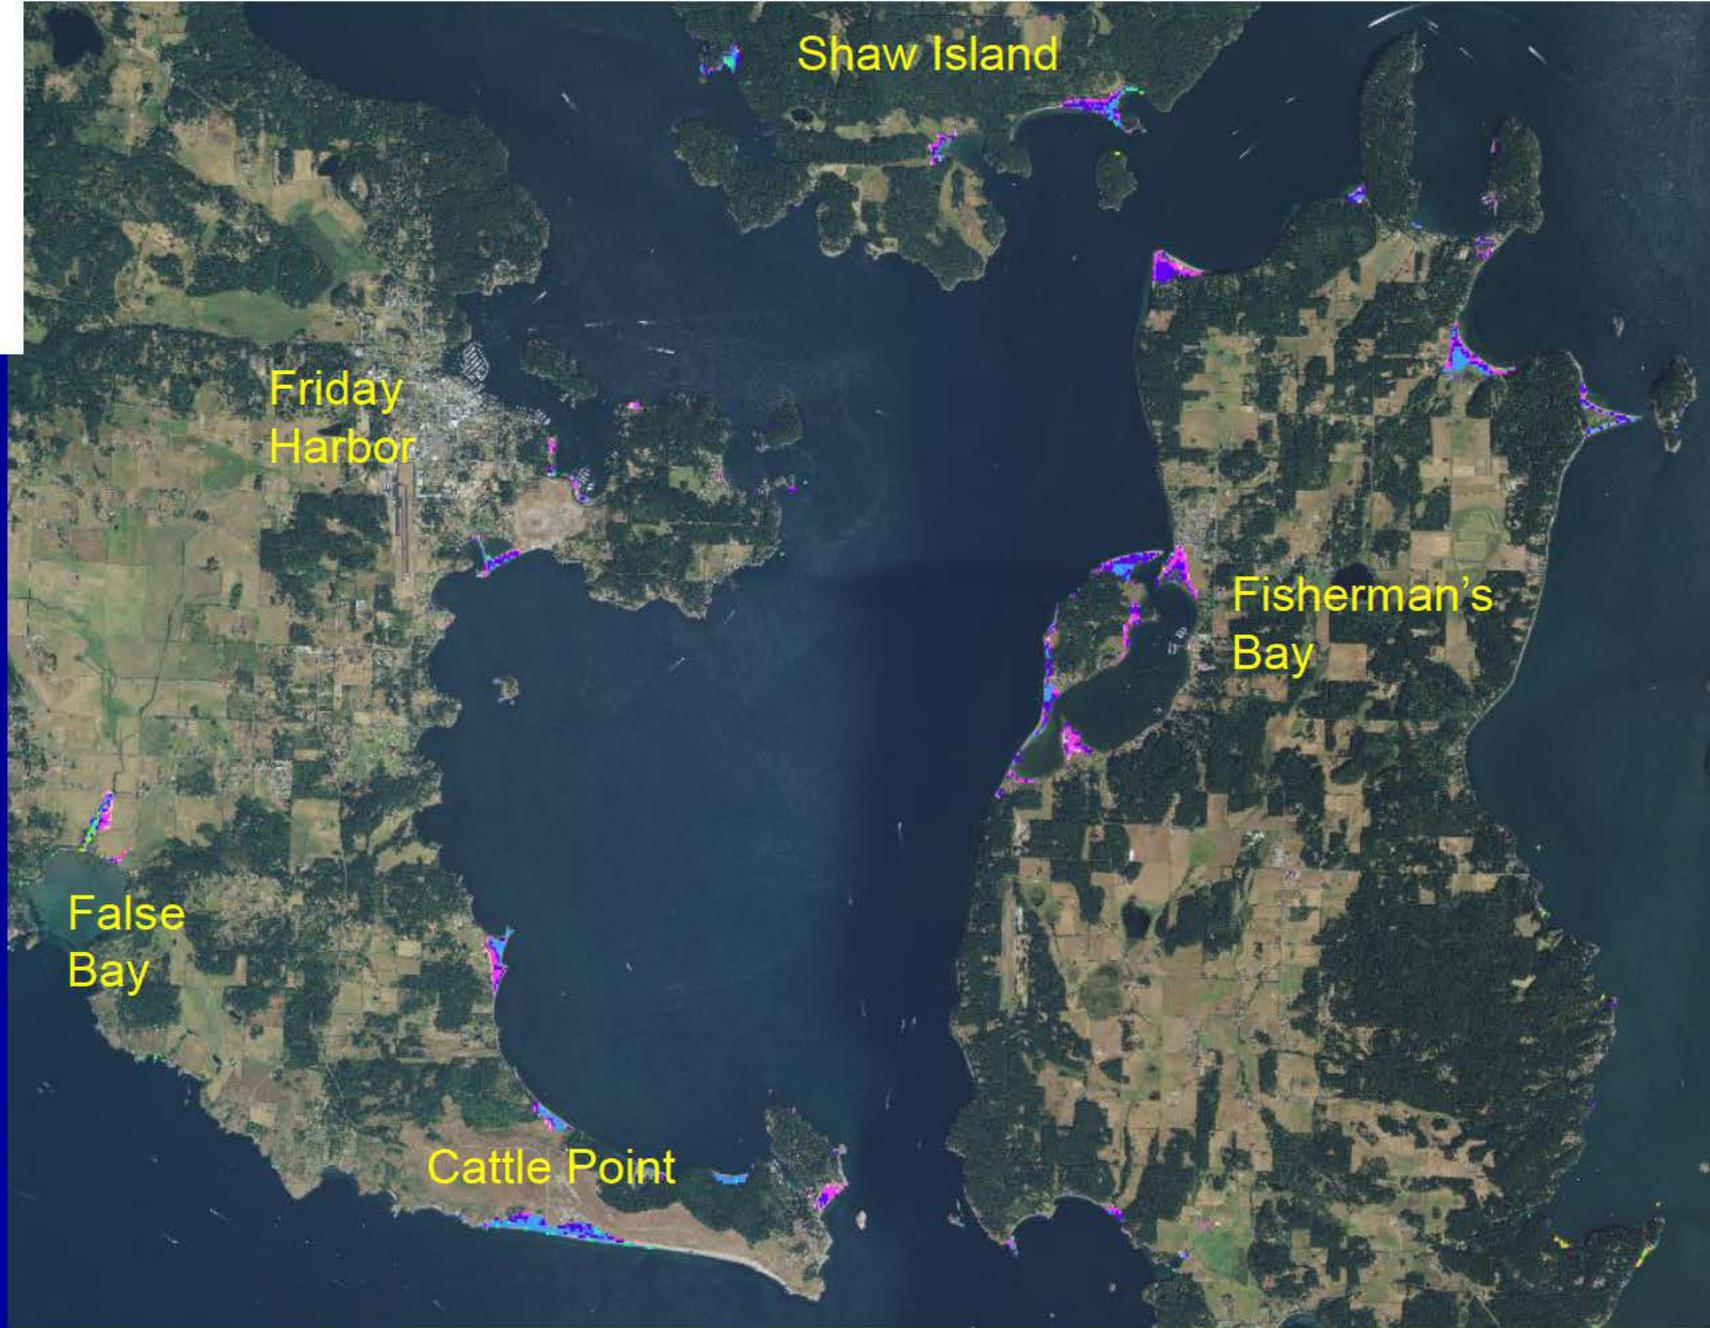
Roche Harbor

- 0 -- 2 ft
- 2 --4 ft
- 4 --6 ft
- 6 --8 ft
- 8 -- 10 ft
- 10 - 12 ft
- 12 -- 14 ft
- 14 --16 ft
- 16 --18 ft

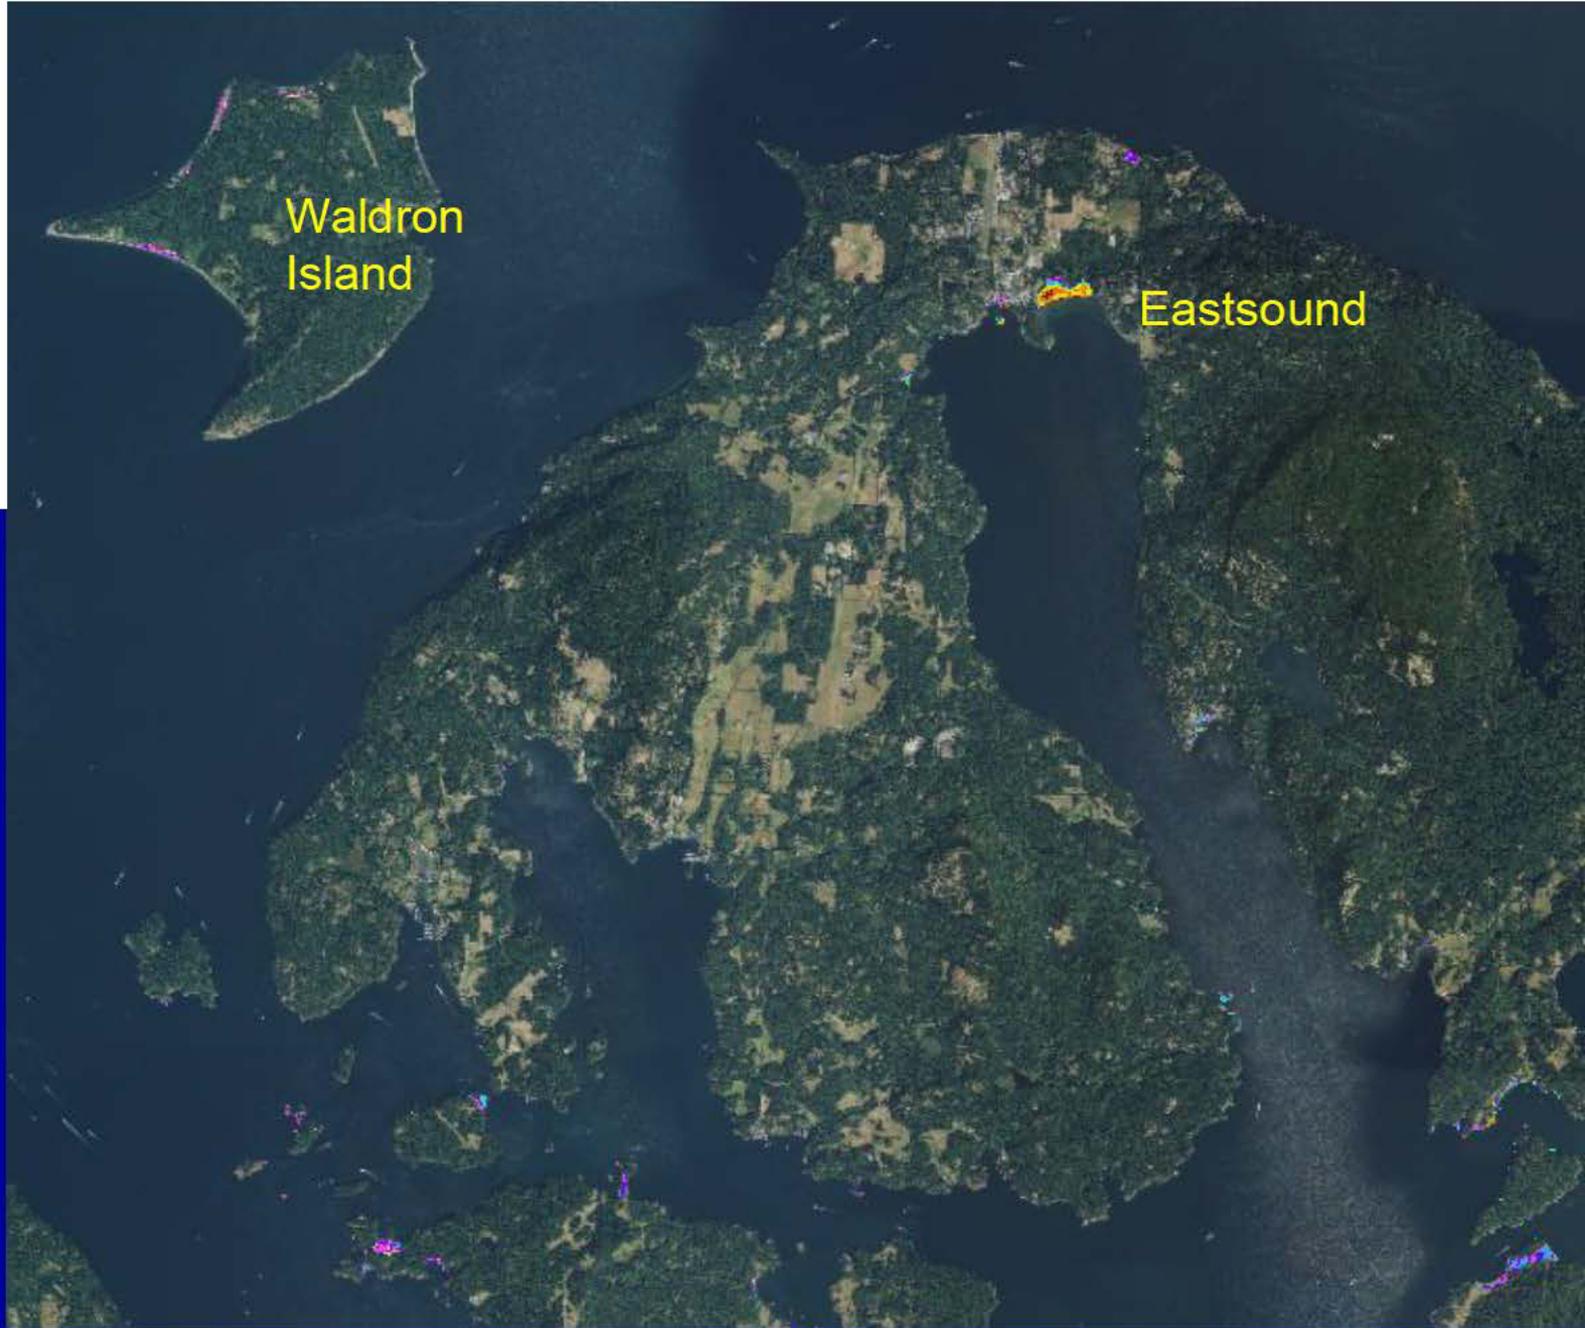
- 0 -- 3 knots
- 3 -- 6 knots
- 6 -- 9 knots
- 9 -- 12 knots
- > 12 knots

Currents from L1 tsunami-- note the currents on the ferry route
