# Studded Tire Wear on Portland Cement Concrete Pavement in the Washington State Department of Transportation Route Network

WA-RD 744.3

June 2010

Research Report  
Agreement T2695, Task 88  
PCCP Best Practices

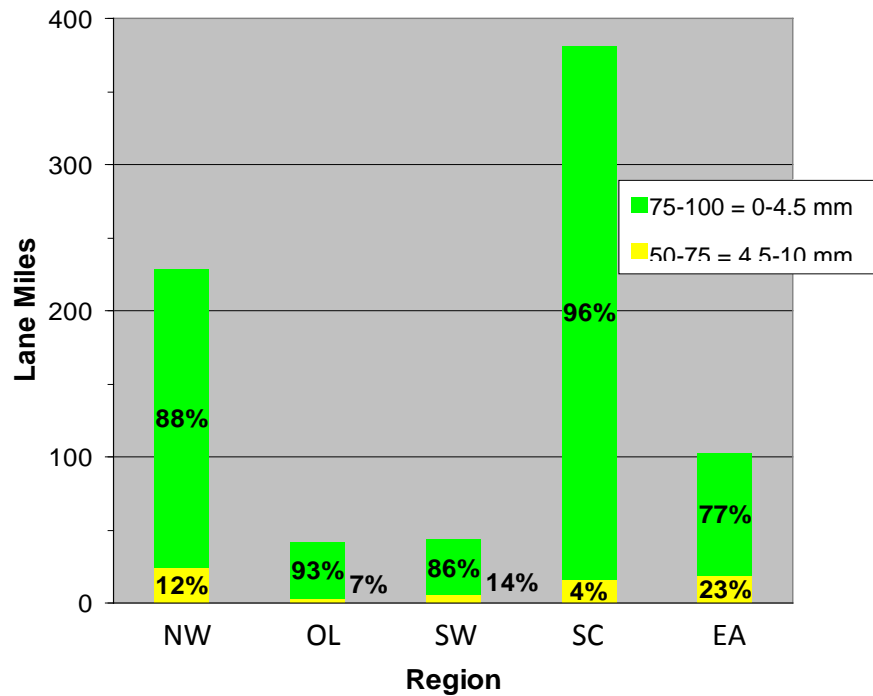
Figure 6 shows the overall 2004 wear condition. From this graph it is clear that the Eastern (EA), Northwest (NW) and South Central (SC) regions have significant amounts of PCC with significant wear depth.

**Figure 6: Current PRC by region.**

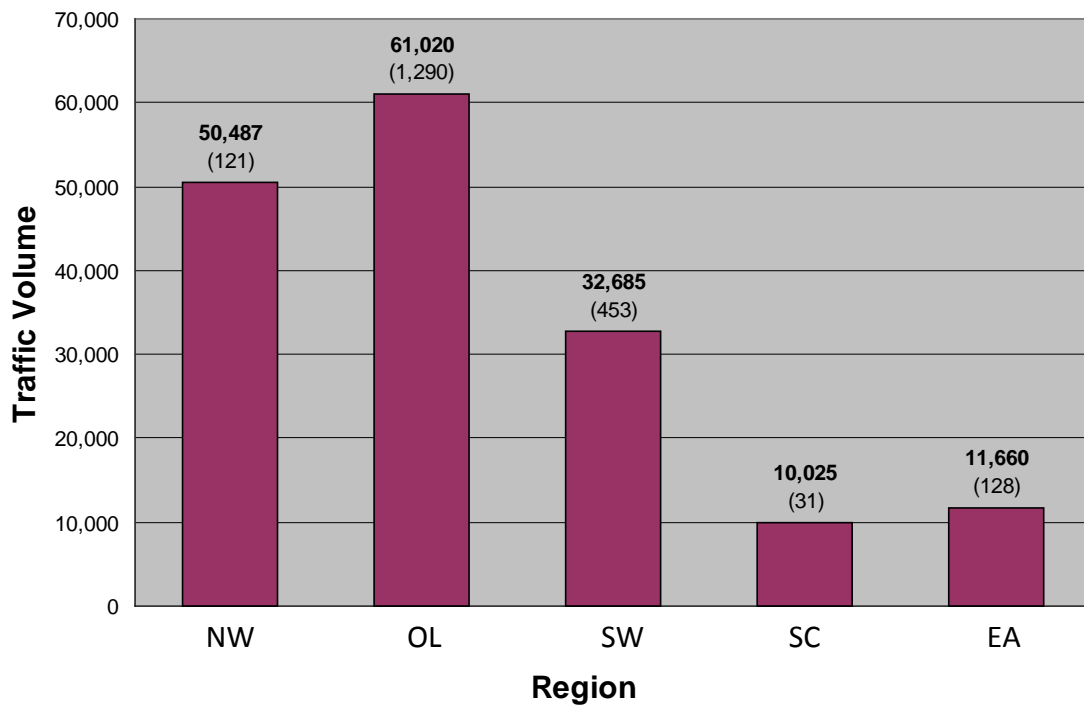
Traffic volumes fluctuate significantly within each region, which impacts pavement condition. Figure 7 shows ADT per region (note that ADT implies this is an average over the whole region) with standard deviation of each shown also in parentheses. The ADT for each region was generated by taking the ADT per each analysis unit, and weighting it by the length of the unit. While it may appear surprising that the Northwest region (NW) does not have the highest ADT, it should be noted that the Olympic region (OL), has only 41 miles of PCC, much of which is on the highly trafficked I-5.

**Figure 7: Average annual daily traffic (AADT) per region.**

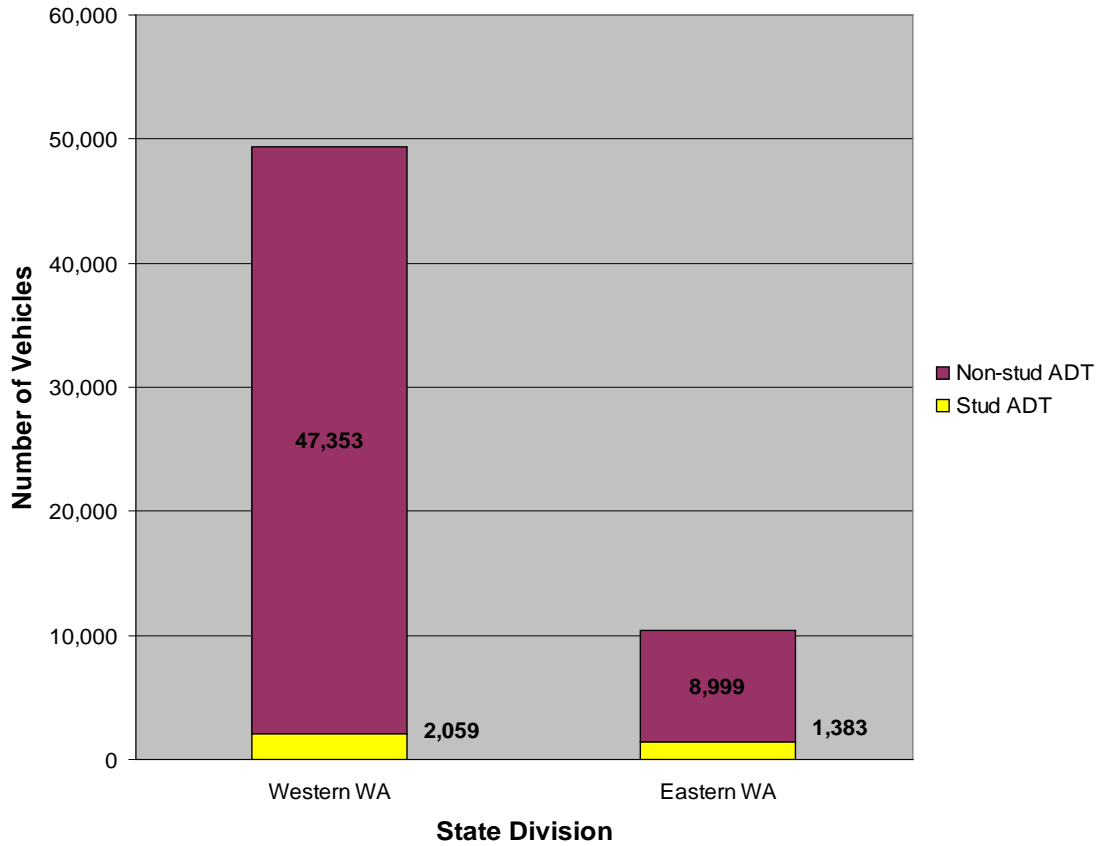
Figure 8 shows stud traffic in Washington State broken down into Eastern and Western areas (Western = Olympic, Northwest and Southwest regions, Eastern = Eastern and South Central). Overall, while stud use is much more common in eastern Washington the higher traffic volumes in the west side actually produce more studded vehicles per day. Given the gross estimates used to obtain these numbers, the stud ADT's for western and eastern Washington should be viewed as essentially equivalent. Also, while these numbers are yearly averages, it should be recognized that on any given day in the winter stud season these stud ADT's will be about double the values shown, and likewise in the summer months there should be no stud traffic.

**Figure 8: Average traffic levels in western Washington and eastern Washington showing non-stud ADT (top) and stud ADT (bottom).**

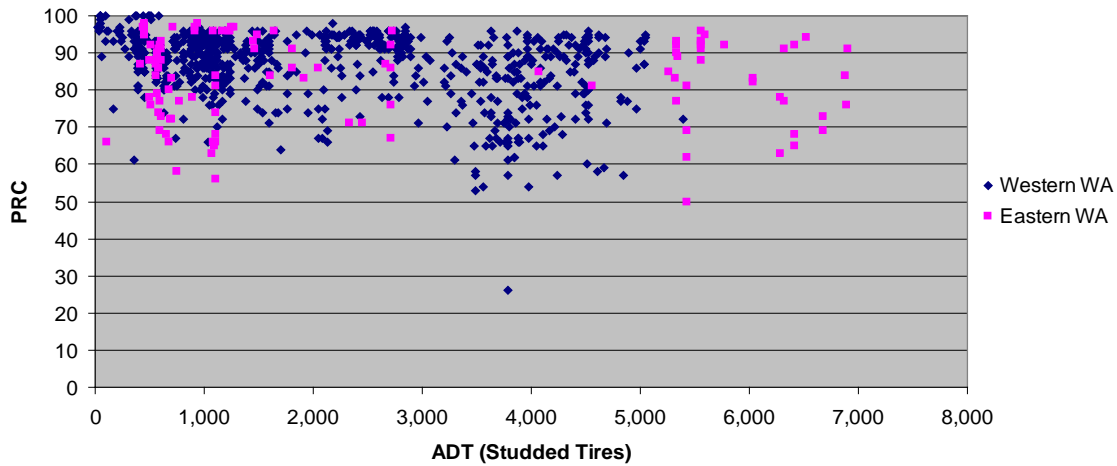
Figure 9 shows stud ADT vs. PRC for each analysis unit. While Figure 9 shows the highest concentration of high-performance pavements are located where stud volumes are lower, there are many exceptions.

**Figure 9: PRC vs. stud ADT.**

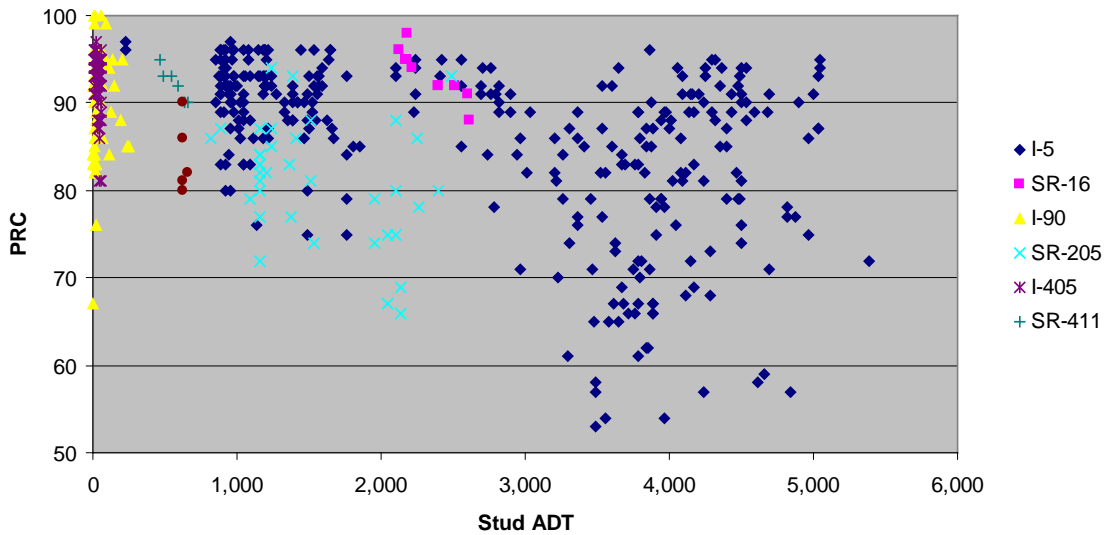
Figure 10 shows pavement performance for each state route with respect to stud volume.

**Figure 10: Distribution of PRC vs. stud ADT by western highway.**

Figure 10 shows a concentration of sections with both lower stud ADT and high PRC scores. The majority of sections that fall below the PRC rating of 80 (the threshold in this study) have higher stud volumes. Some of the low scoring and high scoring sections are further analyzed in the following sections.

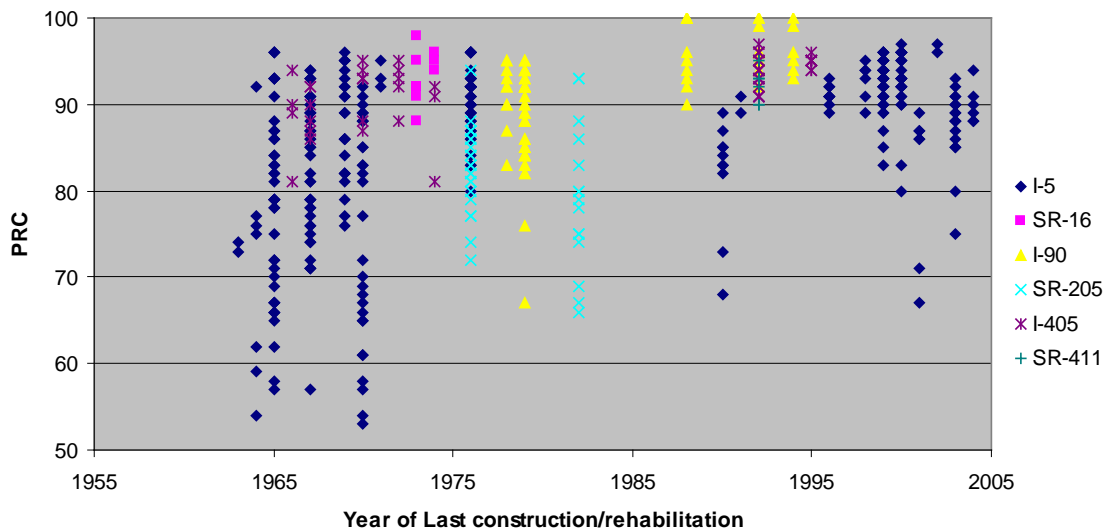
Pavement wear rates can give another indication of performance. Figure 11 shows the most recent year of construction versus PRC score.

**Figure 11: Distribution of PRC vs. age by western highway.**

Projects and their construction times are clearly visible in Figure 11. For example the pink squares represent 1.2 lane miles of 9-inch PCCP at the beginning of SR-16 that was constructed during 1973 and 1974. The average PRC of 94 for this pavement means only 1.1mm of rutting exist after 21 years. It is interesting to note the wide range of rut condition for analysis units built in the same year; many of which likely used the same or

similar materials. It is also interesting to note that some I-5 pavement surfaces that are over 40 years old show similar PRC numbers as those I-5 pavements that were constructed more recently.

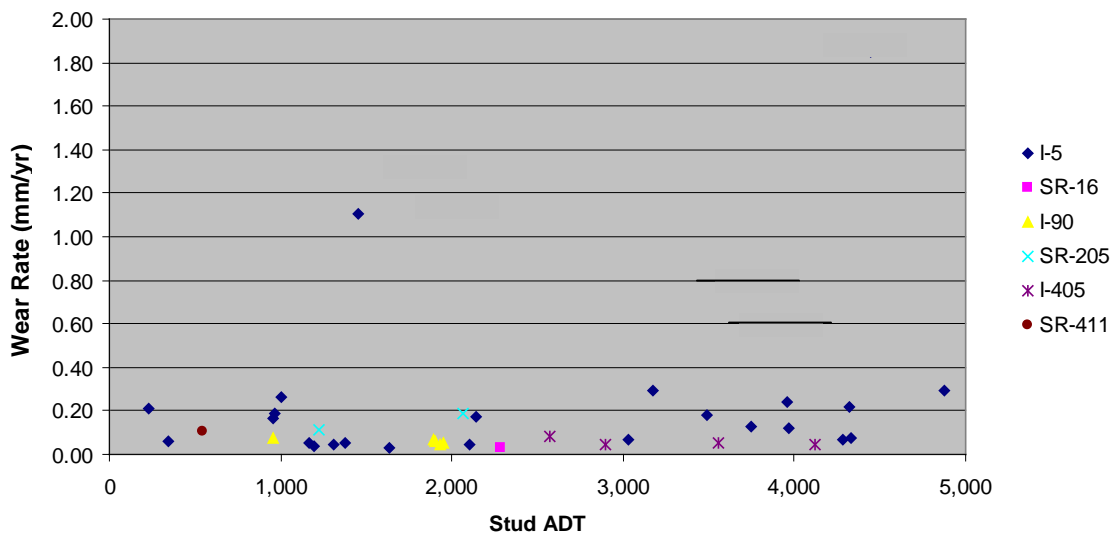
Figure 12 is an alternate way to view wear rates as it plots wear rate against stud ADT. Note that in this figure there is just one section that stand out with an exceptionally high wear rate.

**Figure 12: Western stud ADT vs. wear rate.**

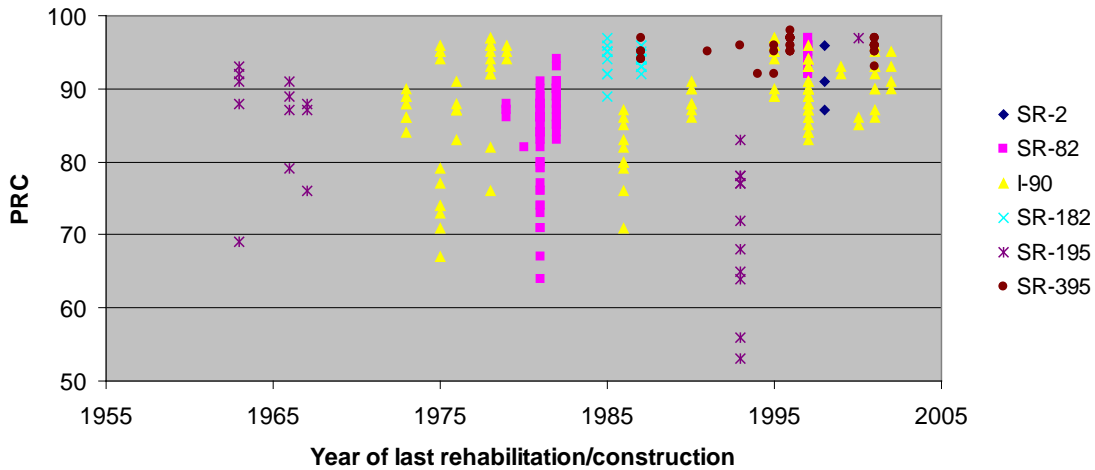
Pavement wear rates can give another indication of performance. Figure 14 shows the most recent year of construction versus PRC score.

**Figure 14: Distribution of PRC vs. age by eastern highway.**

Projects and their construction times are clearly visible in Figure 14. For example sections of SR-90 have been reconstructed or rehabilitated various times over the past few decades, while other highways like SR-82 have not been worked on much since the early 80's. On the other hand it is interesting to see that the work done on SR-195 in the early 90's is performing poorly while the original sections from the 1960's are doing much better.

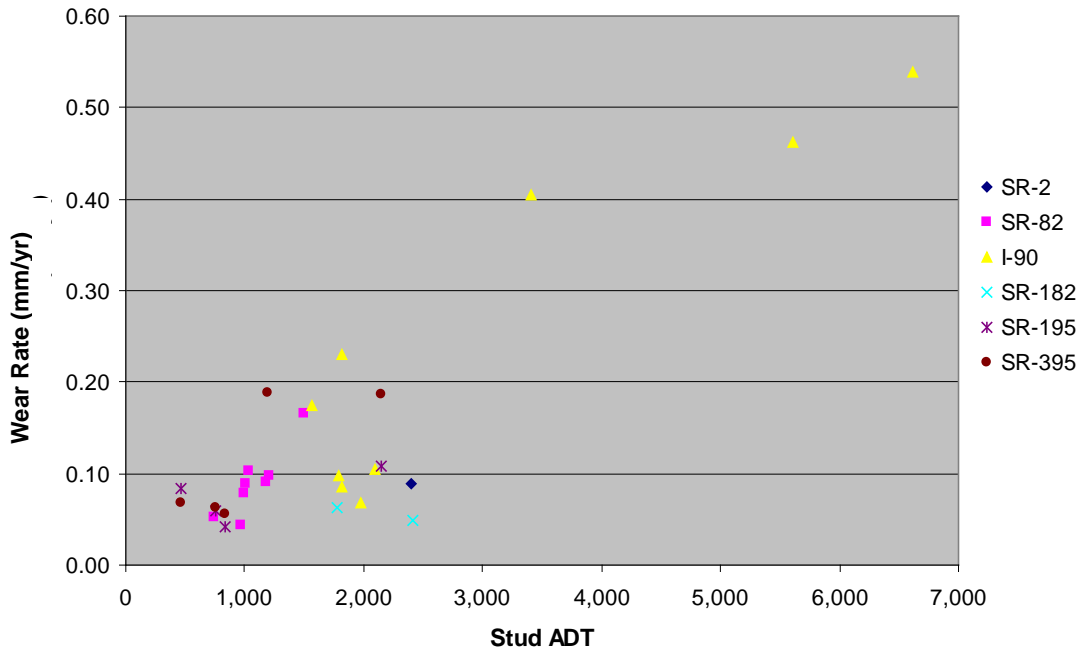
Figure 15 is an alternate way to view wear rates as it plots wear rate against stud ADT. Note that in this figure there are a few sections that stand out with exceptionally high wear rates. A trend of higher wear rates for increasing stud ADT is evident but it may be overemphasized because of the excessive wear rates of the three I-90 sections shown in Table 9.

**Figure 15: Eastern stud ADT vs. rut rate.**

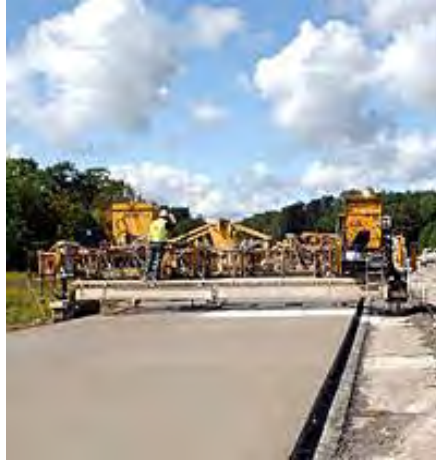
**Process.** There are two main types of PCC overlays applied to existing PCC pavements: bonded and unbonded (FHWA 2007b). A bonded overlay is a thin (typically 4 inches or less) PCC overlay over an existing PCC pavement with a prepared surface. As with a typical HMA overlay, a bonded PCC overlay relies on creating a good bond between the existing pavement and the overlay such that the result behaves as one unified structure (rather than two independent ones). An unbonded overlay is a thicker PCC overlay (usually 6 inches or more) placed over an existing PCC pavement (Figure 16). The overlay is intended to act as a separate pavement and thus steps are taken to ensure bonding to the existing pavement does not occur (ACPA 1998).

**Figure 16: Thin unbonded PCC overlay (Kuennen, 2006)**

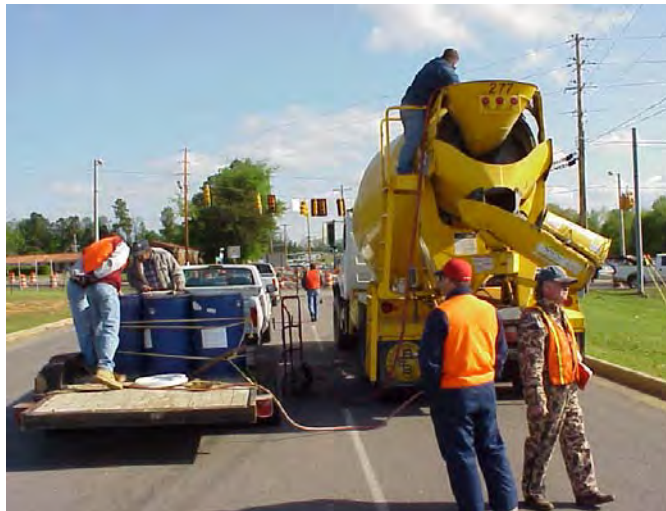
**Figure 17: Latex additive going into the grout (Battey & Whittington, 2007)**

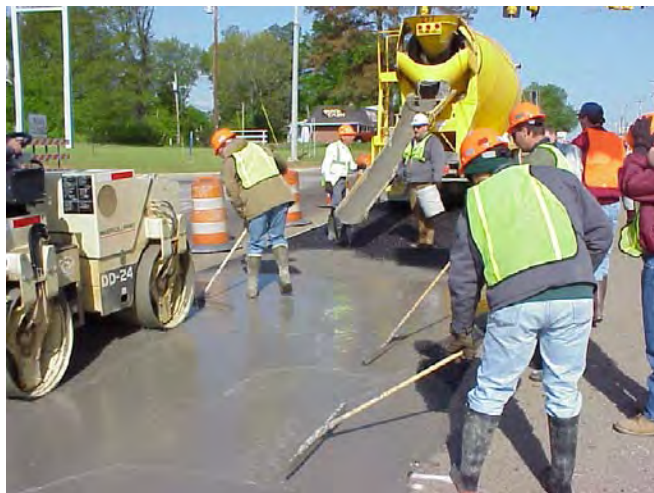
A Mississippi study placed RMP test sections on two HMA pavement intersections on US 72 with histories of traditional rutting (from pavement deformation) (FHWA 2006b). Ultimately, after 5 years of observation between 2001 and 2006, the Mississippi Department of Transportation (MDOT) published a final report in 2007 which featured both positive and negative reviews of their experience with RMP. From the construction end, the project was reported to be very challenging overall. Despite attention to detail, as shown in Figure 18 below, there was one area of failure where the removal of a 75-ft section of the pavement due was required due to a lack of grout penetration of the mat.

**Figure 18: Excess grout worked into areas needing more (Battey and Whittington 2007).**

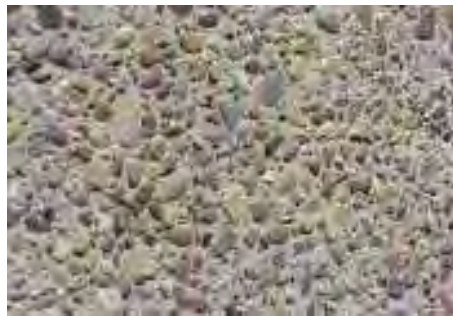
It is possible to construct a new PCC pavement in two separate lifts, which allows different materials to be used in each lift. This technique has been Germany, Austria and Belgium to place a high-quality, carefully engineered top lift over a more basic bottom lift. Often the top lift is constructed with an exposed aggregate finish to lessen tire-pavement noise (Figure 19).

**Figure 19: An exposed aggregate surface (Silent Roads, 2003)**

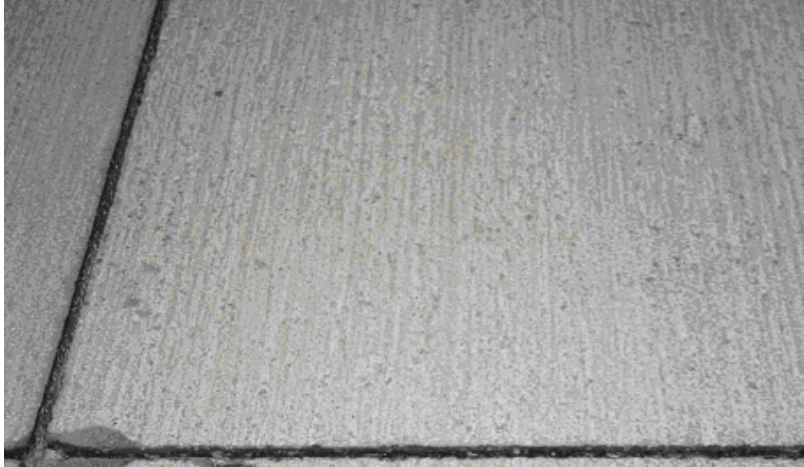
Surface texture is thought to have some correlation to studded tire wear. As the two primary textures used in Washington, the results of transverse tining and artificial turf carpet drag were explored in a WSDOT experiment on the performance of different surface textures (Figure 20). The amount of exposed aggregate relating to surface wear was also examined and it was recognized that pavements initially wore at a higher rate when first exposed to studded tires but then stabilized with time (Anderson et al. 2007). One idea suggested that the difference could be attributed to the paste on the surface of the new concrete. For example the paste wears quickly but then when the aggregate underneath is exposed the pavement wears at a much slower rate. One final conclusion noted was that all of the tined sections in this experiment had faster wear rates than other sections with equivalent mixes. Due to this it was suggested that tining may weaken the surface of the pavement by exposing more surface area to rapid drying, which is an idea that the Texas DOT has also proposed. The additional paste on the tined surface was also noted as a possible contributor (Anderson et al. 2007).

**Figure 20: Surface texture from a carpet drag (Anderson et al. 2007).**

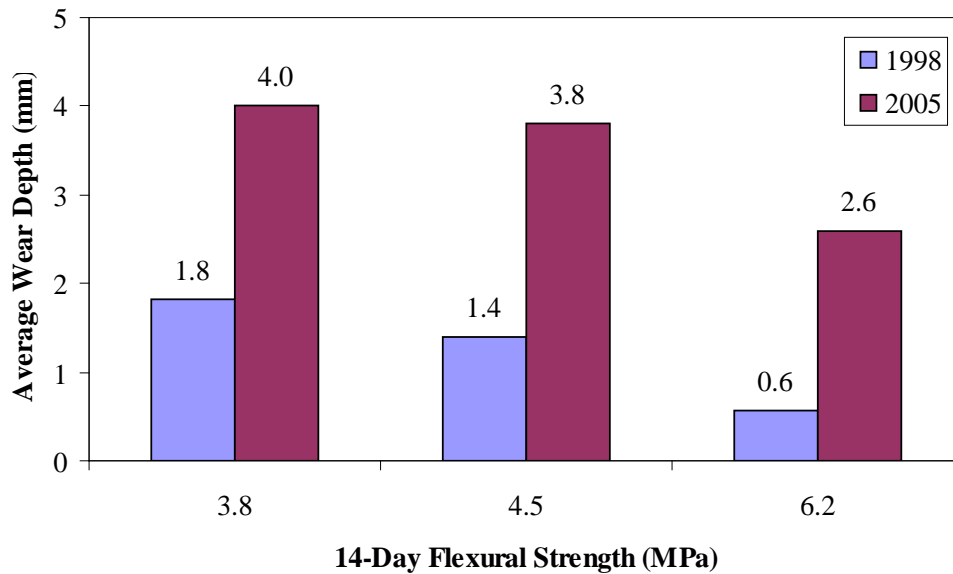
A number of field investigations conducted on a Strategic Highway Research Program Special Pavement Study (SPS-2) site that was constructed in 1995 show that cement content may have some effect in *initial* stud wear rates (Figure 22).

**Figure 22: Pavement wear rates by flexural strength on SR-395 SPS-2 pavement sections.**

It seems that wear rates in the first 3 years (1995-1998) were affected by cement content. Wear rates since then (as measured in 2005) appear to be quite similar for all 3 sections. This suggests that perhaps the weaker paste material at the surface benefited from the higher cement content (and thus strength) but once it wore away, wear rates in all sections equalized.

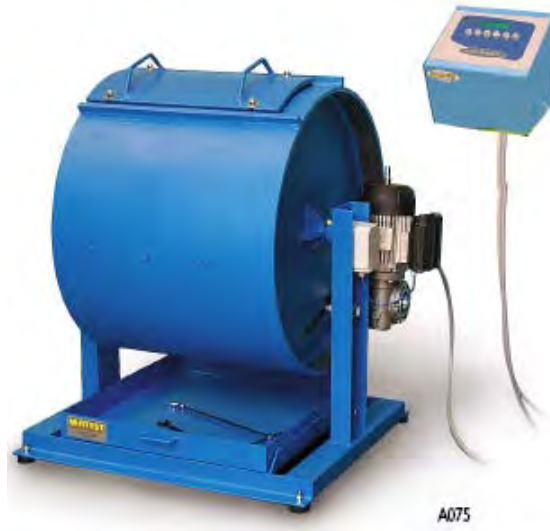
standard Los Angeles abrasion test is AASHTO T 96 or ASTM C 131. Figure 24 is an example of the LA Abrasion machine.

**Figure 24: LA Abrasion machine (Qualitest International, Inc. 2009).**

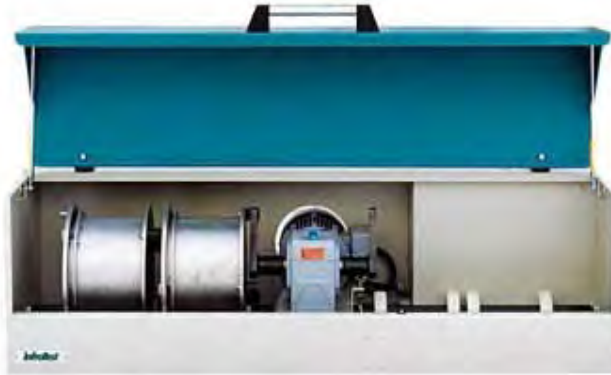
The Micro-Deval test (Figure 25) is another test used to evaluate the performed of an aggregates resistance to wear, and is similar to the LA Abrasion test. There are two versions of the test available. The test is described as placing the sample in a steel jar with steel balls (9.5 mm in diameter) and water, then rotating the jar at 100 rpm for 2 h for coarse aggregates, as previously described, or 15 min for fine aggregates (Land et al. 2006). Then the aggregate damage is assessed by mass loss using a 1.25-mm sieve for coarse aggregates and a 75- $\mu$ m sieve for fine aggregates (Lang et al. 2006).

**Figure 25: A Micro-Deval test machine (Inopave 2003).**

Unlike the LA Abrasion test, this test method is unique in that the aggregates are tested in saturated conditions rather than dry-conditions. According to the South Carolina DOT, analysis indicated that Micro-Deval test method is a better test in characterizing aggregate's field performance. The SCDOT found that for any given source of aggregate, finer gradation consistently yielded higher losses compared to coarser gradations (Rangaraju et al. 2005). Further, a Micro-Deval loss limit of 17% identified nearly all of the aggregates that were rated as being "fair" or "poor" in field performance.
